Spatial and temporal analysis of the collapse of the tailings dam in Brumadinho, Brazil

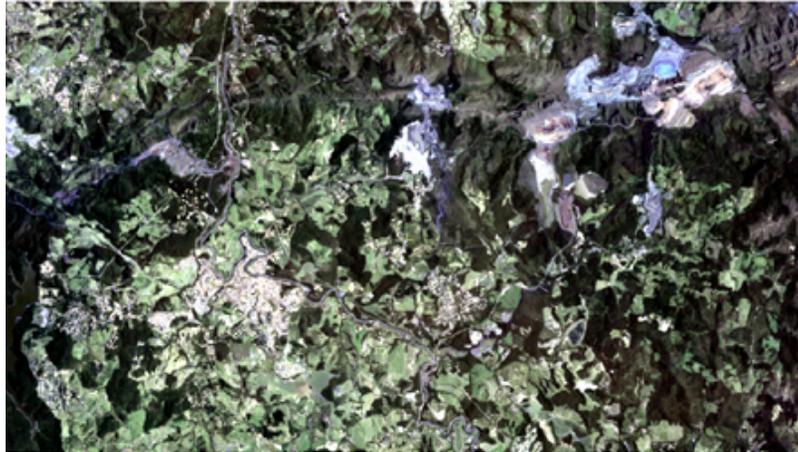
Figure 5 – Cutouts performed on the mosaic composed with images of the study area acquired on January 22, 2019.

The cutouts performed on the mosaics resulted in images for each time, as shown in Figures 5 and 6.

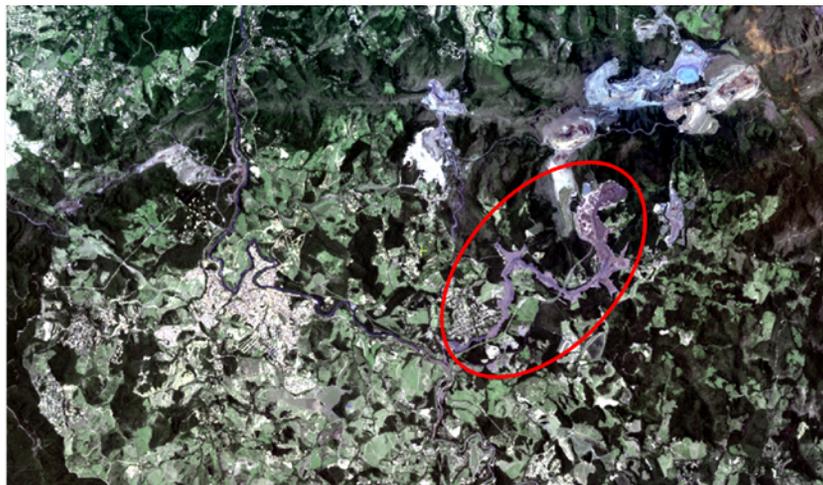
Figure 06 – Cutouts performed on the mosaic composed with images of the study area acquired on February 1st, 2019.

The cutouts showed the extension of the area affected after the collapse of the dam, identified by the area marked in red in Figure 6.

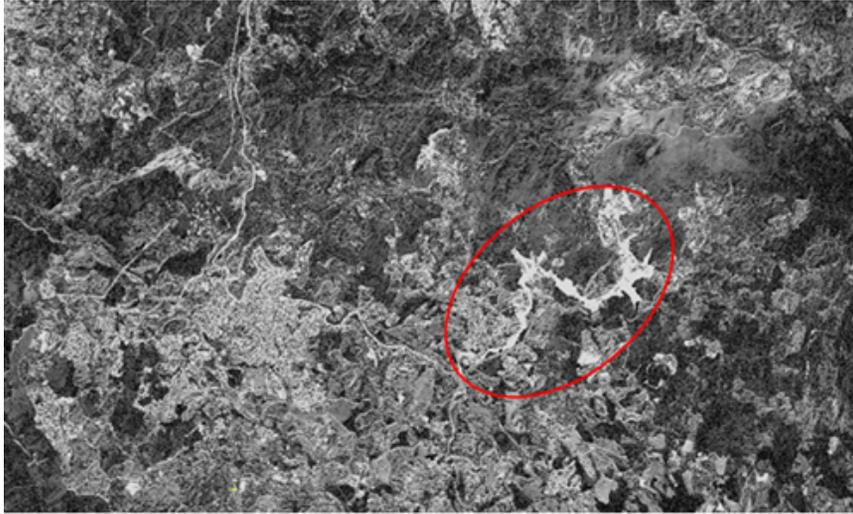
Figure 7 – Detected changes according to the *PCI Geomatics* software.

The area highlighted in white in Figure 7, represents the greatest changes detected by the processing done, and denotes the presence of tailings. The area highlighted in red and blue, in Figure 8 also denotes the presence of tailings. The different colors are explained by differences in land cover before the collapse of the dam: the area represented in red was covered with clear water, and the area in blue was covered with vegetation, constructions, and soil.

Therefore, Figures 7 and 8 show the changes occurred in the study area after the collapse of the dam. The change detection using the software *ENVI 5.3* enabled the use of thresholds to isolate the affected area, removing small changes from the process to quantify the affected area.
